NO NAME 791 DAM
(COVES LAKE DAM)

PLATTE COUNTY, MISSOURI

MISSOURI INVENTORY NO. 10929

PHASE I INSPECTION
NATIONAL DAM SAFETY PROGRAM

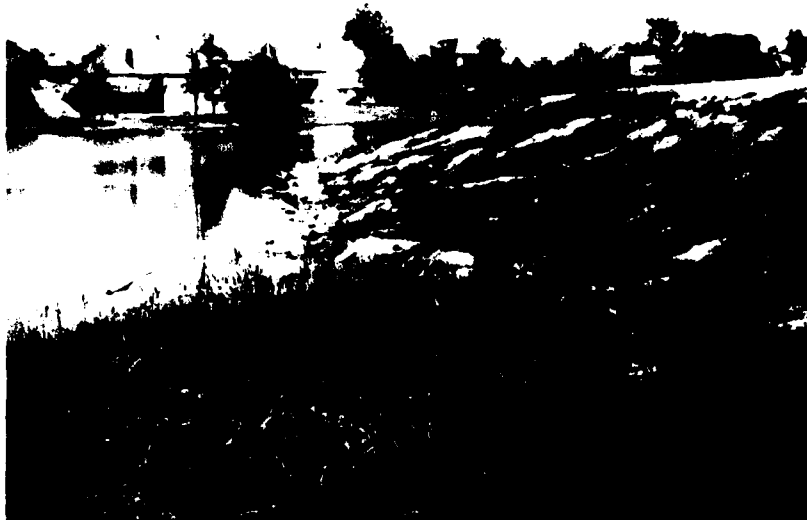
PHOTO 1: UPSTREAM FACE OF DAM (LOOKING NORTH)
